## FULL BUILDING SURVEY REPORT

SAMPLE REPORT, SAMPLE  
STREET, DA9 9XR

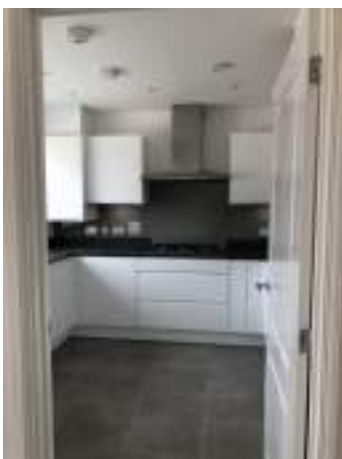
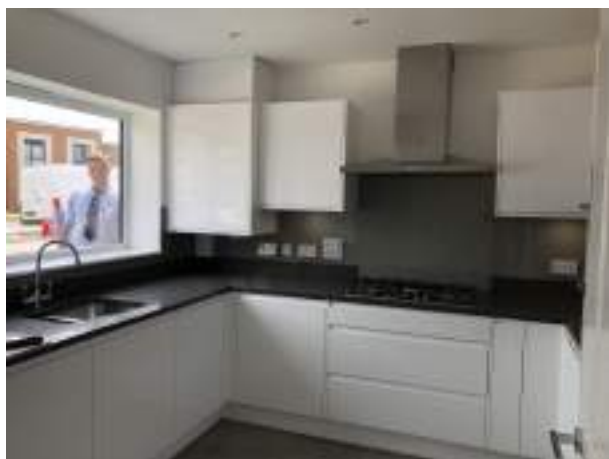
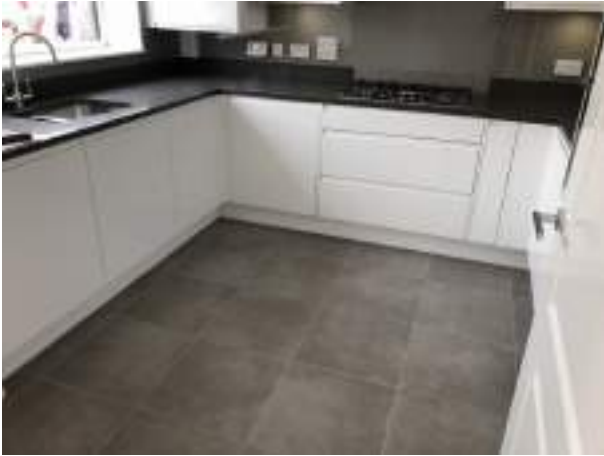
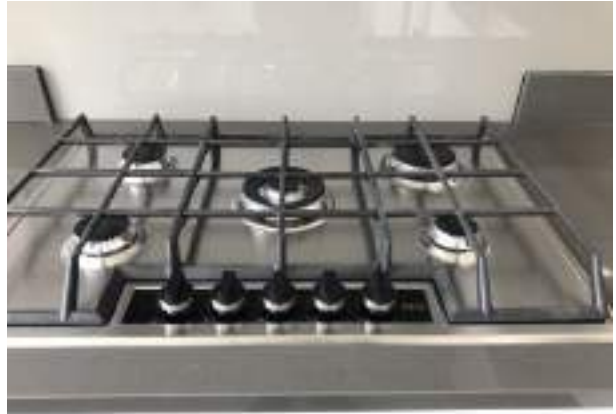
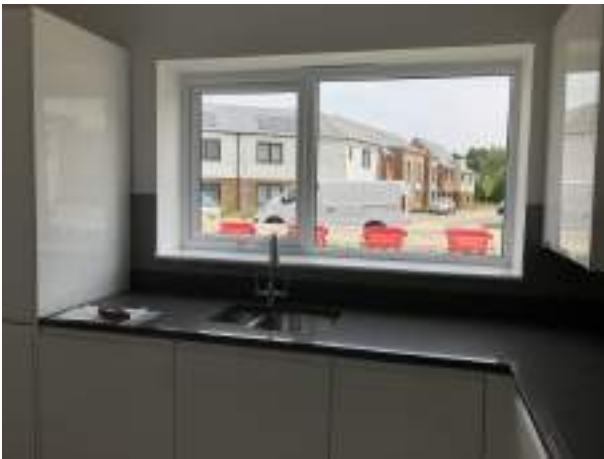
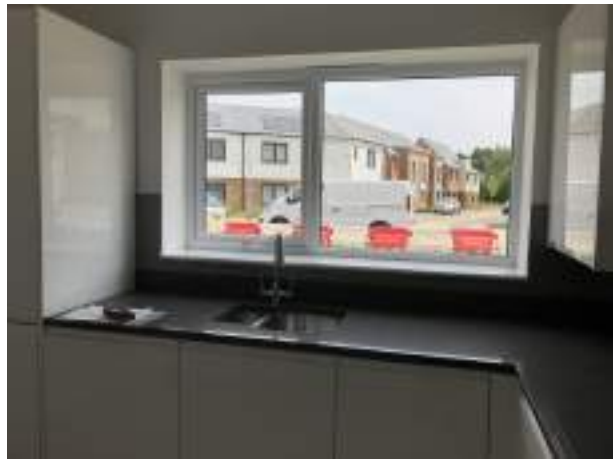
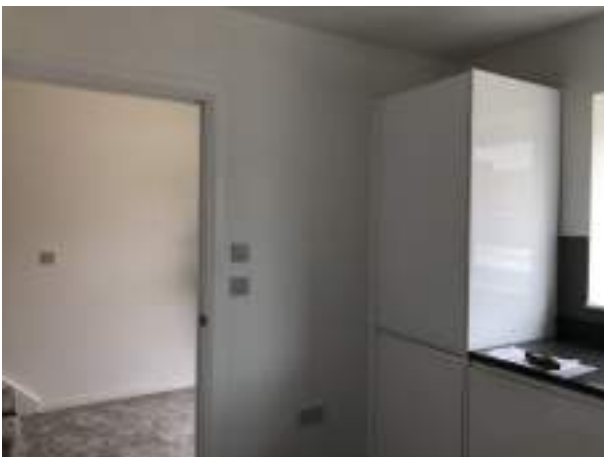
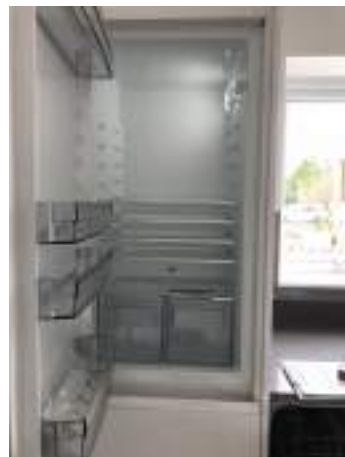
Room/Area	Location	Front/Rear/Center	Photos and Observations
Kitchen	Ground Floor	Rear	[Photos 11 - 18]
Porch	Ground Floor	Front	Bees nesting in roof.
