FULL BUILDING SURVEY REPORT

SAMPLE REPORT, SAMPLE
STREET, DA9 9XR

SRDA99XR

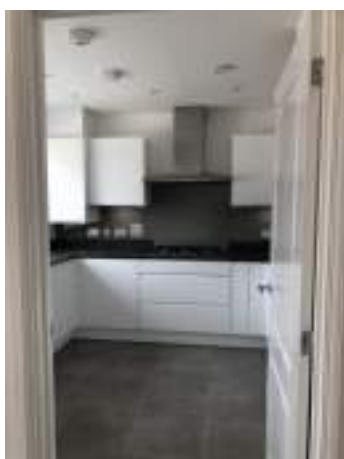
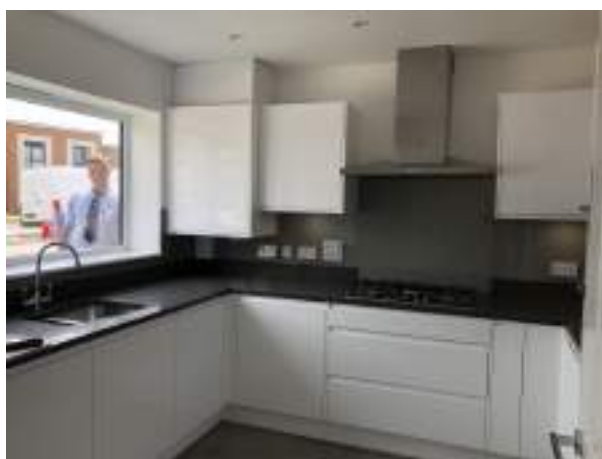
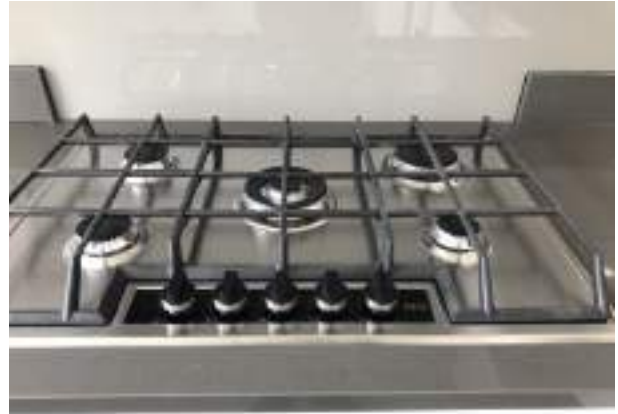
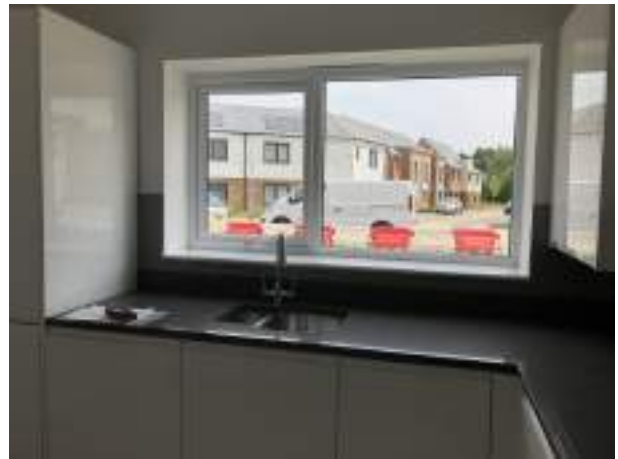
Room/Area	Location	Front/Rear/Center	Photos and Observations
Kitchen	Ground Floor	Rear	[Photos 11 - 18]
Porch	Ground Floor	Front	Bees nesting in roof.
